SECTION 7

O-Ring Troubleshooting and Failure Analysis

COMMON O-RING FAILURE MODES

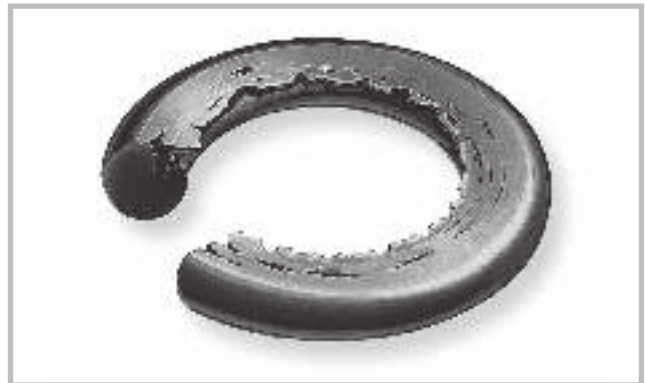
EXTRUSION OR NIBBLING

The seal develops ragged edges, generally on the low pressure side, which appear tattered. This condition is more common with high pressure systems.

- Excessive clearances
- Excessive system pressure
- Irregular clearance gaps due to eccentricity
- Sharp groove edges
- Low-modulus/low-hardness elastomer
- Softening of elastomer due to fluid incompatibility
- Excessive gland fill
- Expansion of cylinder wall due to pressure

- ▶ Decrease clearances
- ▶ Decrease system pressure if possible
- ▶ Use back-up ring
- ▶ Increase rigidity and concentricity of metal components
- ▶ Break edges of groove to minimum of .004" (0.10mm)
- ▶ Use higher-modulus/higher-hardness elastomer
- ▶ Use more chemically compatible elastomer
- ▶ Increase groove width or change o-ring size
- ▶ Stiffen cylinder wall to limit expansion

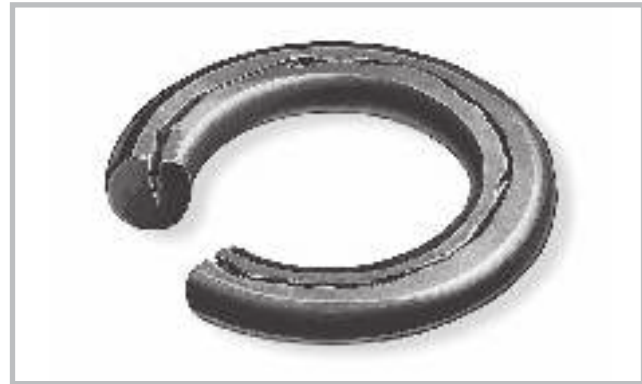
OVER-COMPRESSION

The seal exhibits parallel flat surfaces corresponding to the sealing surfaces. May also develop circumferential splits within the flattened surfaces.

- Excessive compression squeeze
- Elastomer with poor compression set properties
- Elastomer with inadequate heat resistance
- Elastomer that swells excessively in system fluid
- Improperly cured part used

- ▶ Use smaller o-ring or adjust gland dimensions
- ▶ Use material with better compression set resistance
- ▶ Use more heat resistant elastomer
- ▶ Use more chemically resistant elastomer
- ▶ Check cure state of parts prior to installation

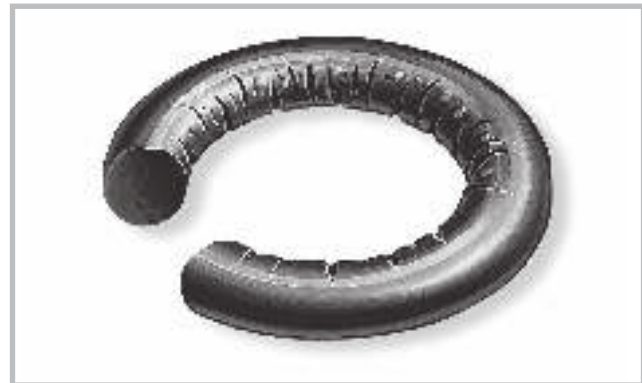
HEAT HARDENING/THERMAL DEGRADATION

The seal may exhibit radial cracking on the highest temperature surfaces, often accompanied by the flattening of the seal characteristic of over-compression. Certain elastomers may exhibit signs of softening, such as a shiny surface.

- Thermal properties of elastomer
- Excessive temperatures, temperature excursions or temperature cycling

- ▶ Select more heat-resistant elastomer
- ▶ Select elastomer containing antioxidants
- ▶ Consider possibility of cooling sealing surfaces
- ▶ Increase thermal mass to dampen temperature cycling or excursions
- ▶ Change the position of the gland away from heat source

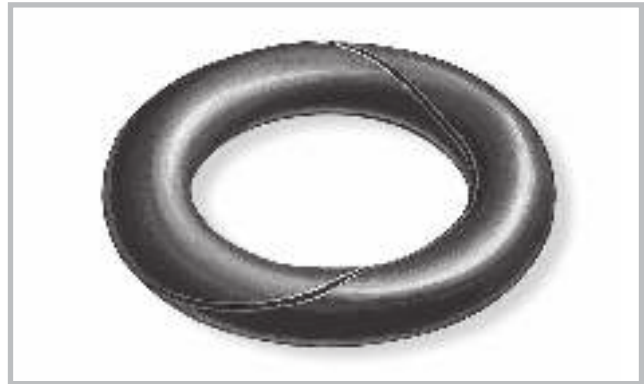
SPIRAL FAILURE

The seal surface exhibits a series of deep, spiral, 45°-angle cuts. This failure is often seen with long-stroke, hydraulic piston seals.

- Eccentric components
- Wide clearances in combination with side loads
- Uneven surface finishes
- Inadequate lubrication
- Elastomer is too soft
- Stroke speed too slow—dynamic reciprocating

- ▶ Increase rigidity and concentricity of metal components
- ▶ Decrease clearances
- ▶ Machine metal surfaces to 10 to 20 pinch surface finish
- ▶ Specify an external lubricant or use an internally lubricated material
- ▶ Use a higher durometer material
- ▶ Increase stroke speed or use D-ring instead of o-ring

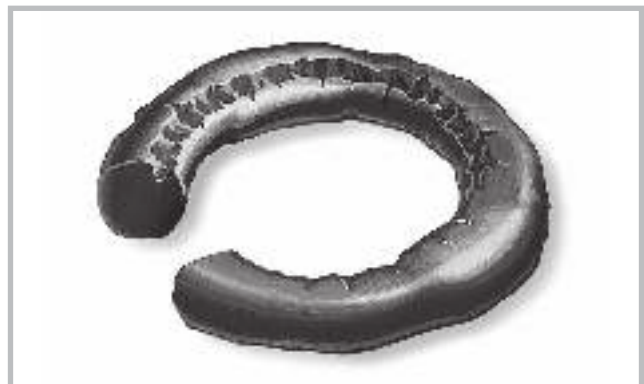
CHEMICAL DEGRADATION

The seal may exhibit many signs of degradation including blisters, cracks, voids or discoloration. However, in some cases the degradation is only detectable by measurement of physical properties.

- Incompatibility with chemical environment

- ▶ Use more chemically resistant elastomer
- ▶ Use PTFE encapsulated o-rings
- ▶ Decrease temperature that o-ring sees, as higher temperatures accelerate chemical degradation

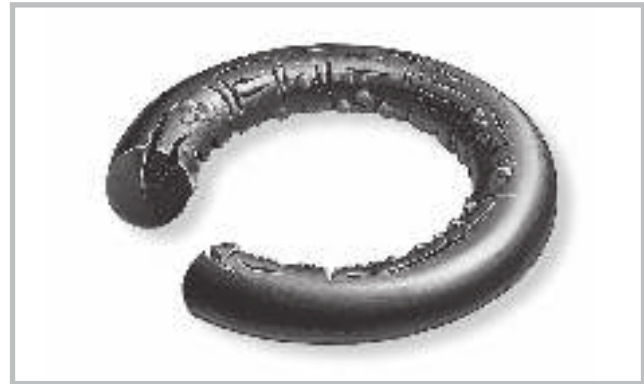
EXPLOSIVE DECOMPRESSION

Explosive decompression results when high-pressure gases are absorbed by the seal, and then, as the pressure is rapidly dropped, the expanding gasses are trapped in the micropores of the elastomer, causing surface blisters and ruptures as they escape. The effected seals will exhibit random short splits or ruptures deep into the seal cross-section. When first removed the surface may also be covered with small blisters.

- Rapid pressure drop from high pressure
- Low-modulus/low-hardness elastomer

- ▶ Slow the release of system pressure
- ▶ Specify a higher-modulus/higher-hardness material
- ▶ Specify a decompression-resistant material

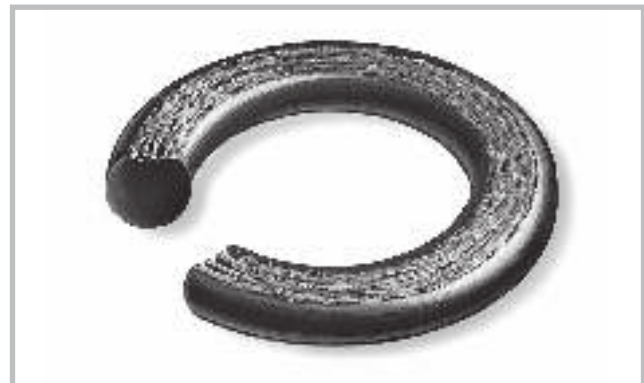
ABRASION

Abrasion occurs only with dynamic seals—seals involved with a rotary, oscillating or reciprocating motion. The seal or parts of the seal exhibit a single flat surface parallel to the direction of motion. Loose particles and scrapes may be found on the seal surface.

- Rough sealing surfaces
- Sealing surfaces too smooth to allow for adequate lubrication
- Process environment containing abrasive particles

- ▶ Use recommended gland surface finishes
- ▶ Use recommended gland surface finishes
- ▶ Eliminate abrasive components or protect seal from exposure to them

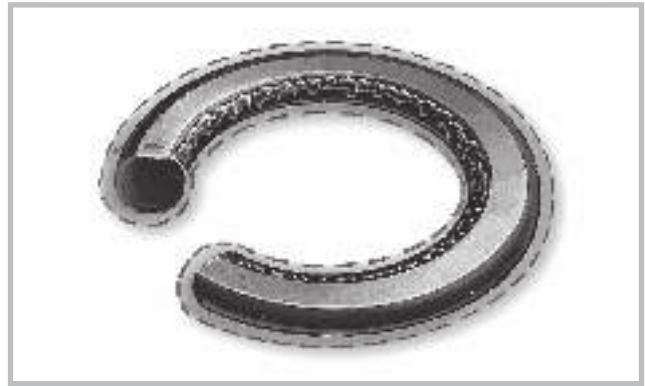
PLASTICIZER EXTRACTION

Seen primarily in fuel systems, plasticizer extraction is characterized by a loss of volume or weight of the seal. It is often difficult to detect with only a visual inspection.

- Heavy use of plasticizers to achieve low-temperature properties or hardness
- Exposure to organic solvents compatible with plasticizers used

- ▶ Switch to elastomer with low-temperature properties so plasticizers aren't needed
- ▶ Change plasticizers used to ones less compatible with process fluids

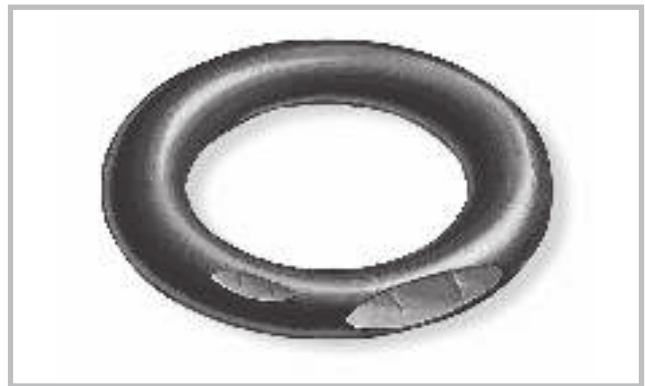
INSTALLATION DAMAGE

The seal or parts of the seal may exhibit small cuts, nicks or gashes.

- Sharp surfaces on glands or components
- Inadequate lead-in chamfer
- O-ring too large for gland
- Low-modulus/low-hardness elastomer

- ▶ Break all sharp metal edges and cover threads with tubes or tape for installation
- ▶ Provide a 15° lead-in chamfer of adequate length so o-ring sees only chamfer
- ▶ Review gland and o-ring design per recommended design standards
- ▶ Specify a higher-modulus/higher-hardness material

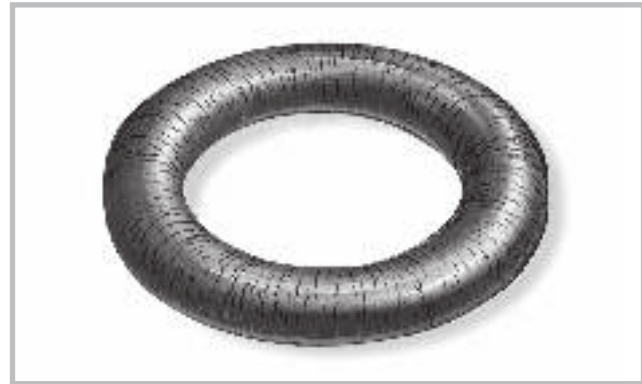
WEATHER OR OZONE CRACKING

Occurring in seals exposed to ozone, UV radiation or other air pollutants, weather or ozone cracking is characterized by small surface cracks perpendicular to the direction of stress.

- Exposure to ozone, UV radiation or other air pollutants
- Excessive seal stretch (>5% ID stretch)

- ▶ Select more ozone- and UV-resistant elastomer
- ▶ Apply anti-ozonant or wax coating to seal
- ▶ Modify the design to avoid the damaging exposure
- ▶ Modify design to reduce stretch to less than 5%
